VERIFICATION REQUIREMENTS FOR COVER SYSTEMS

Technical Guidance for
Developers,
Landowners and
Consultants

**Yorkshire and Lincolnshire
Pollution Advisory Group**

Version 3.4 – November 2017

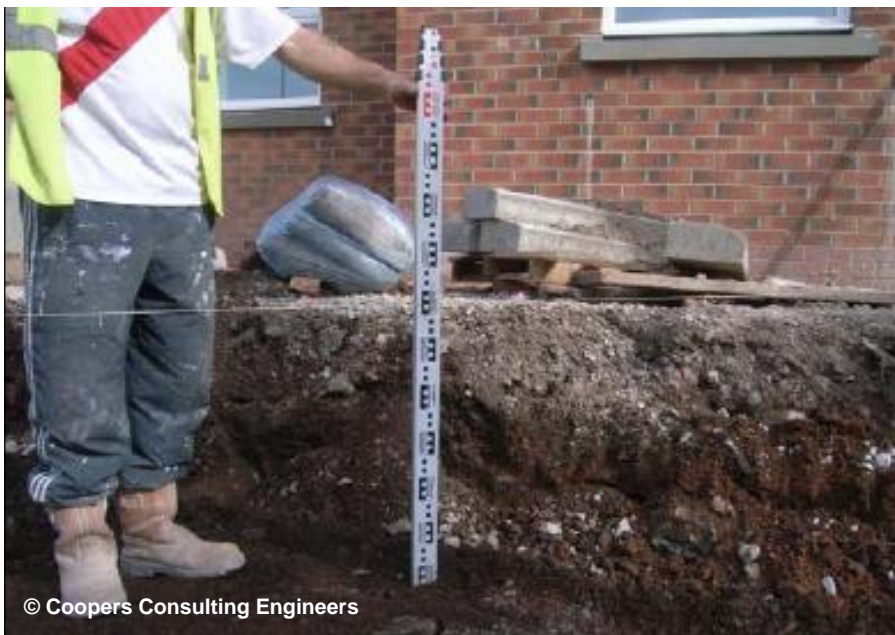
Photographs 3 & 4:
Depth check of inert
cover within areas of
front gardens.
